INDUSTRIAL HYGIENE REPORT

Robert Morris School
122 Elizabeth Street
South Bound Brook, New Jersey 08880

November 14, 2018

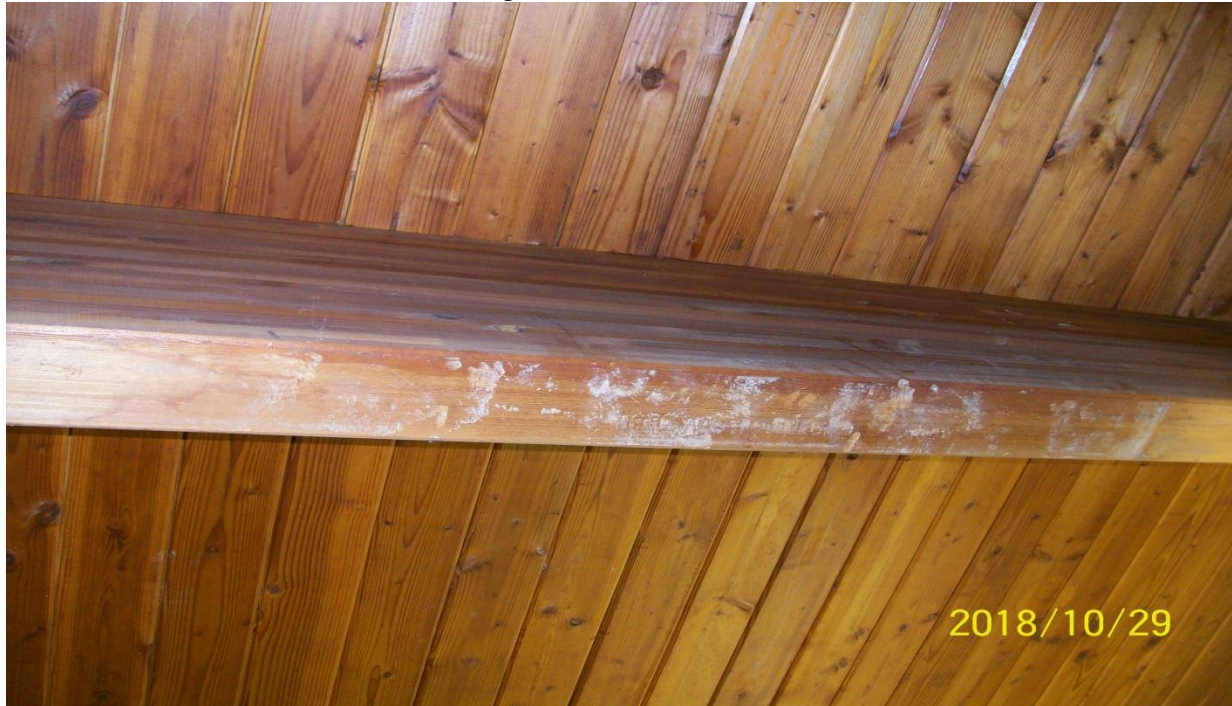
Small area of suspect mold growth was observed on the wood paneled ceiling joist; surface sample was taken. Moisture measurements of the wood paneling were at acceptable levels <6% moisture content. Normal moisture content for wood is 15% or less on the wood reference scale on the moisture meter.

Visual inspection of all areas inspected was acceptable with no visible mold growth, odors or moisture detected in the areas. The laboratory results of the swab sample taken on the wood panel ceiling joist in Room 132 came back as non-detect for mold spores. We believe the tested discoloration is dirt/dust.

#1 –Room 132 – Wood Paneled Ceiling Joist with dust.

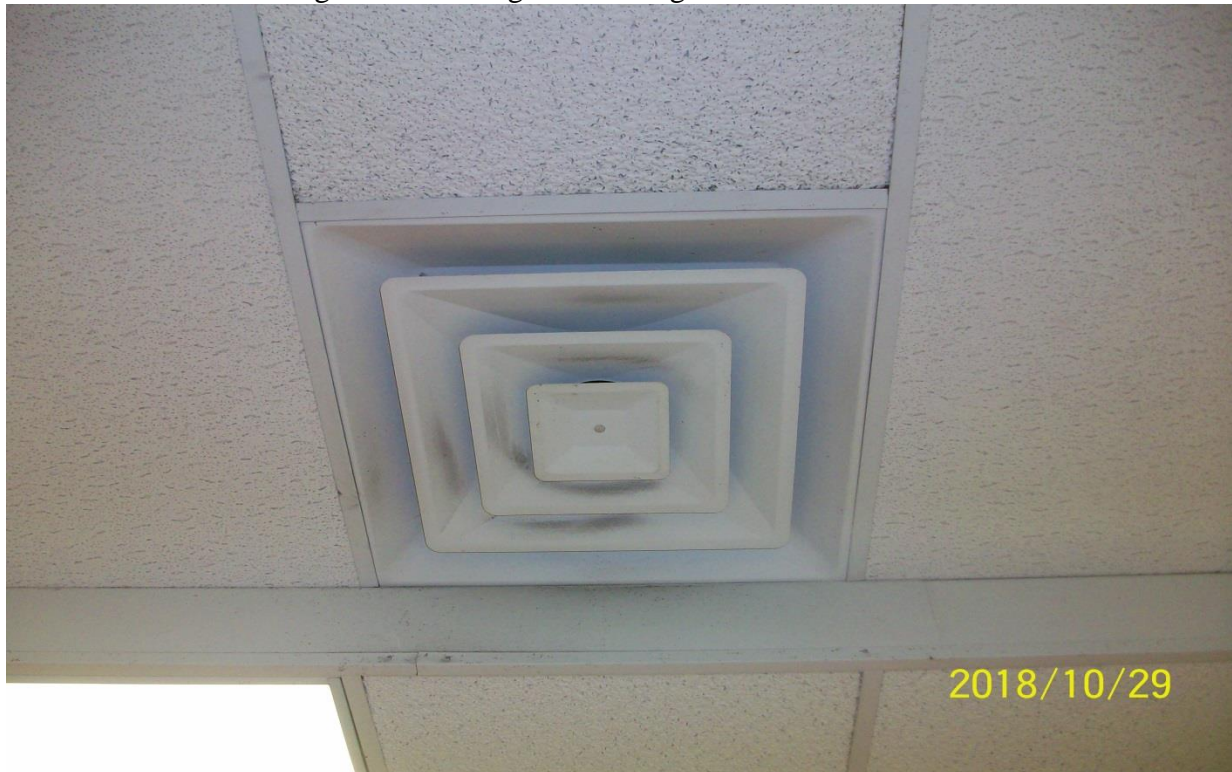
Many surfaces had light to moderate layers of dust and most HVAC registers were dusty and/or dirty.

#2 – Room 135 – Ceiling ventilation register with light dust.

4. Carry out regular preventive maintenance of all systems including inspections of air handler interiors, seasonal replacement of filters and regular cleaning of registers and diffusers. All such activities must be fully documented in the District's NJPEOSH Indoor Air Quality (IAQ) compliance files.

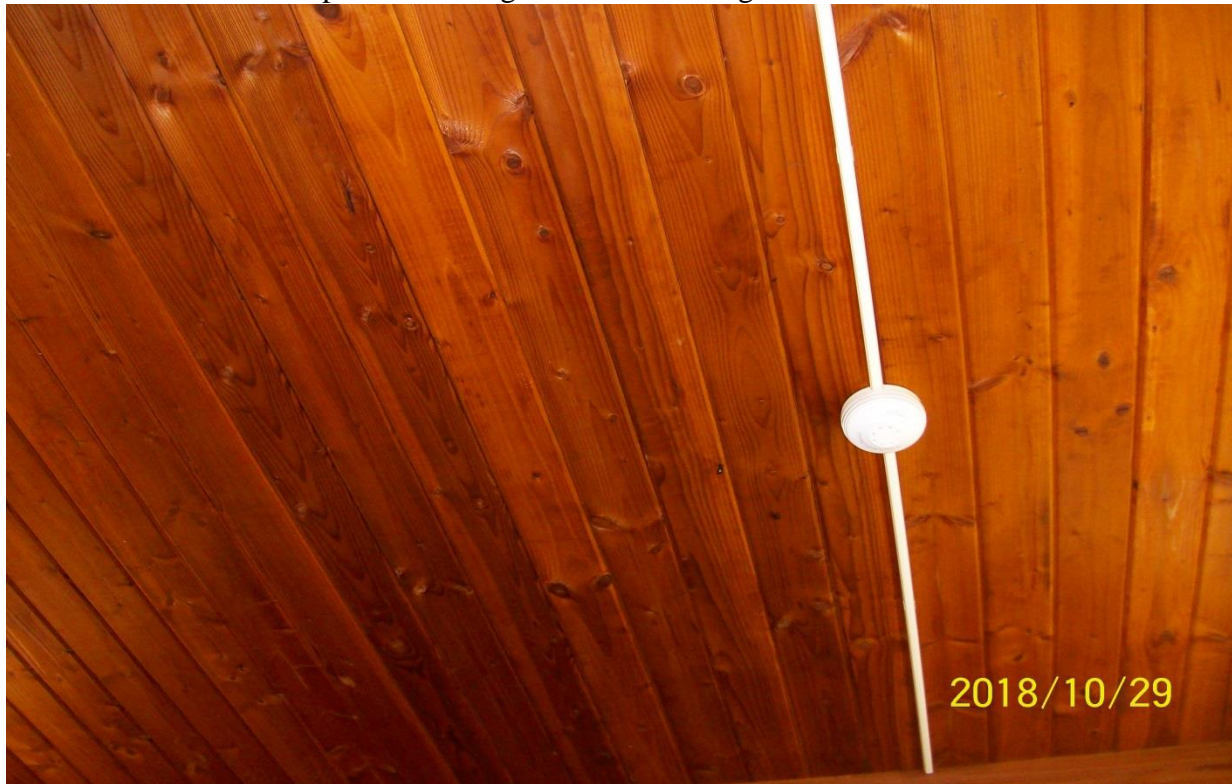
No mold-like or other unusual odors were detected upon entry and no suspect mold growth was observed on any surfaces.

#3 – Room 140 – Wood paneled ceiling – Normal Findings

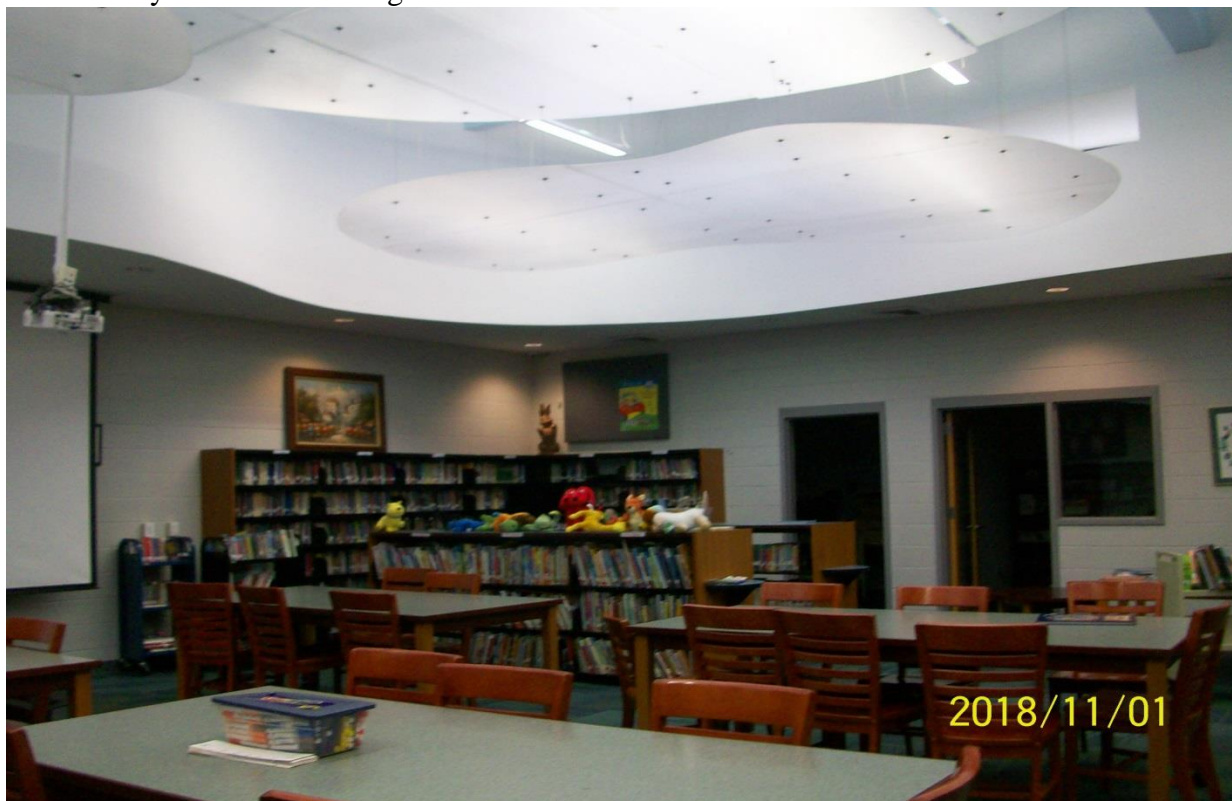
All surfaces, including the ceiling and books appeared clean with no suspect mold growth present.

Moderate layer of dust found on HVAC registers and the top surfaces of bookcases/shelves.

#4 – Library – Normal Findings

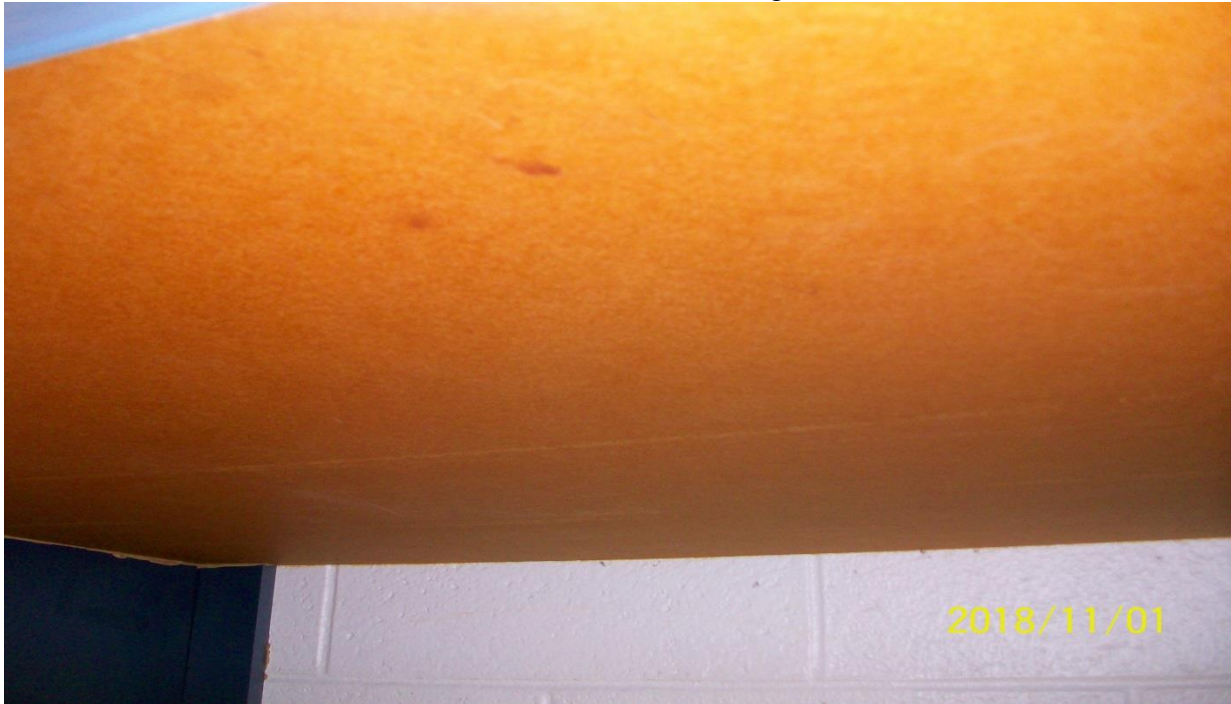
#5 – Room 208 – Bottom of classroom table – normal findings.
